## FICHE DE TEST

| Projet | H13 EARise | | |
| Indice de test | <b>T01_Défaillance_21FR001</b> | | |
| Contexte | Profileur bitête récupéré suite défaillance | | |

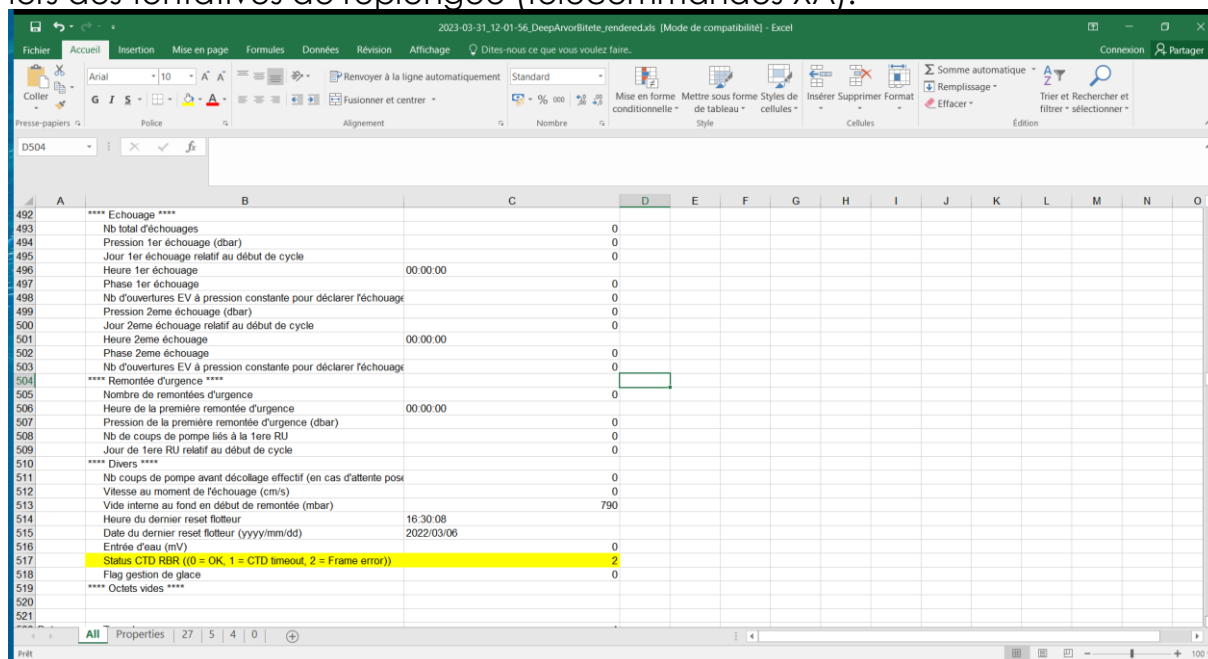
Contrôle du statut de la CTD RBR transmis par message technique le 02/09/22 lors des tentatives de replongée (télécommandes XA).

| | A | B | C | D | E | F | G | H | I | J | K | L | M | N | O |
|---|---|---|---|---|---|---|---|---|---|---|---|---|---|---|---|
| 517 | Status CTD RBR ((0 = OK, 1 = CTD timeout, 2 = Frame error)) | | | 2 | | | | | | | | | | | |

Flag d'erreur de la CTD RBR : Frame error.
